INFLUENCE OF SUBGRADE SOIL ON PAVEMENT PERFORMANCE: A CASE STUDY OF AGO-IWOYE – ILISHAN ROAD, SOUTHWESTERN NIGERIA

J. O. Fatoba¹, A. O. Sanni², A. B. Ayantunji¹

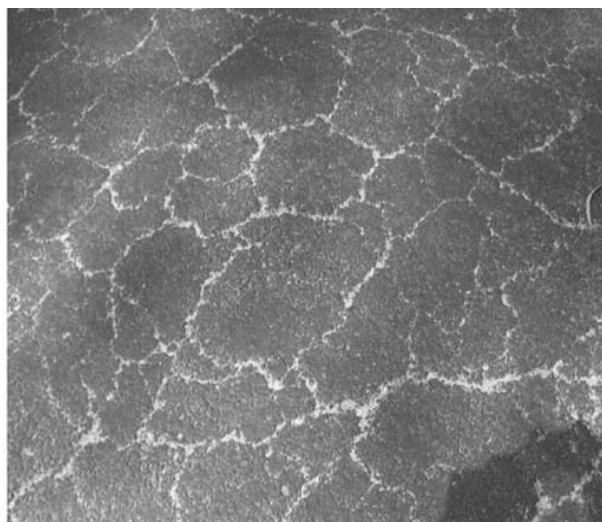
Plate 1: Cracks on the pavement of the study Highway

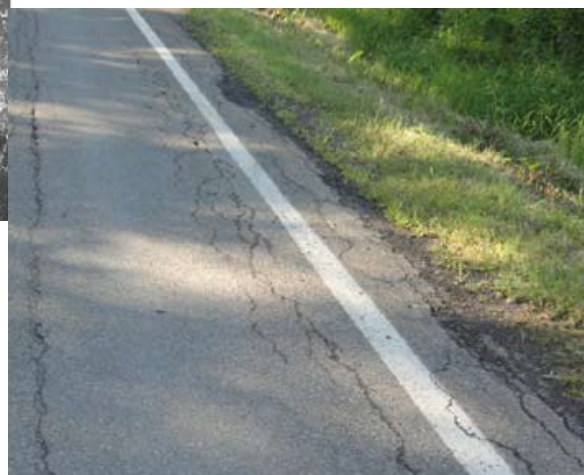
Plate 2: Cracks on the pavement of the study Highway

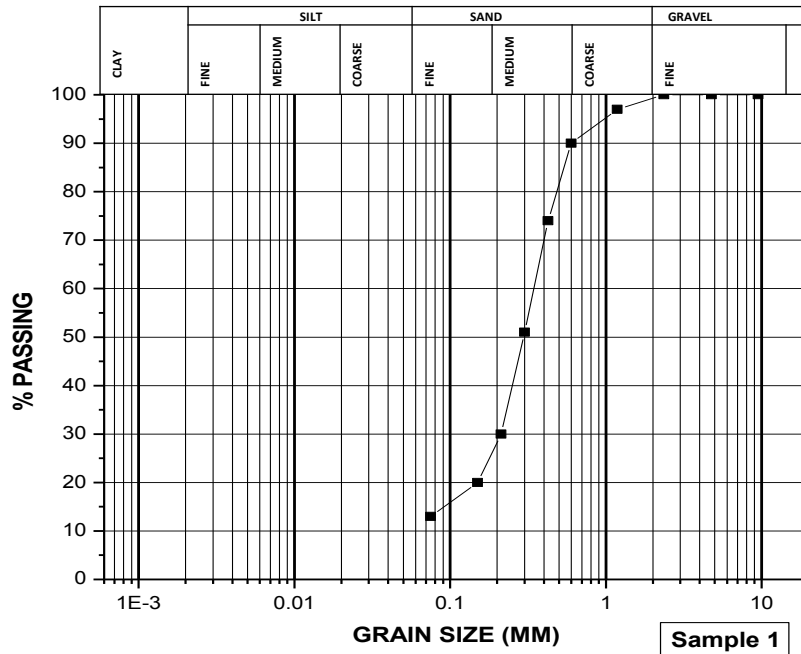
Figure 3a. Grain size distribution curve for Sample 1

Figure 3a shows the grain size distribution curve for sample 1 where the percentage of soil passing is plotted against the grain size (mm). This shows that percentage of coarse soil is 86%, while that of fine soil is 14%. For figure 3b, the percentage of coarse soil is 98% and fine soil is 2%. Table 1 shows the summary of the geotechnical properties of the subgrade soils. The values represent the average for three replicate of each sample tested.
